Freeman Lake Eco Harvester Field Log July 2025

Treatment Event Overview & Background Information

Field Log - July 23, 2025

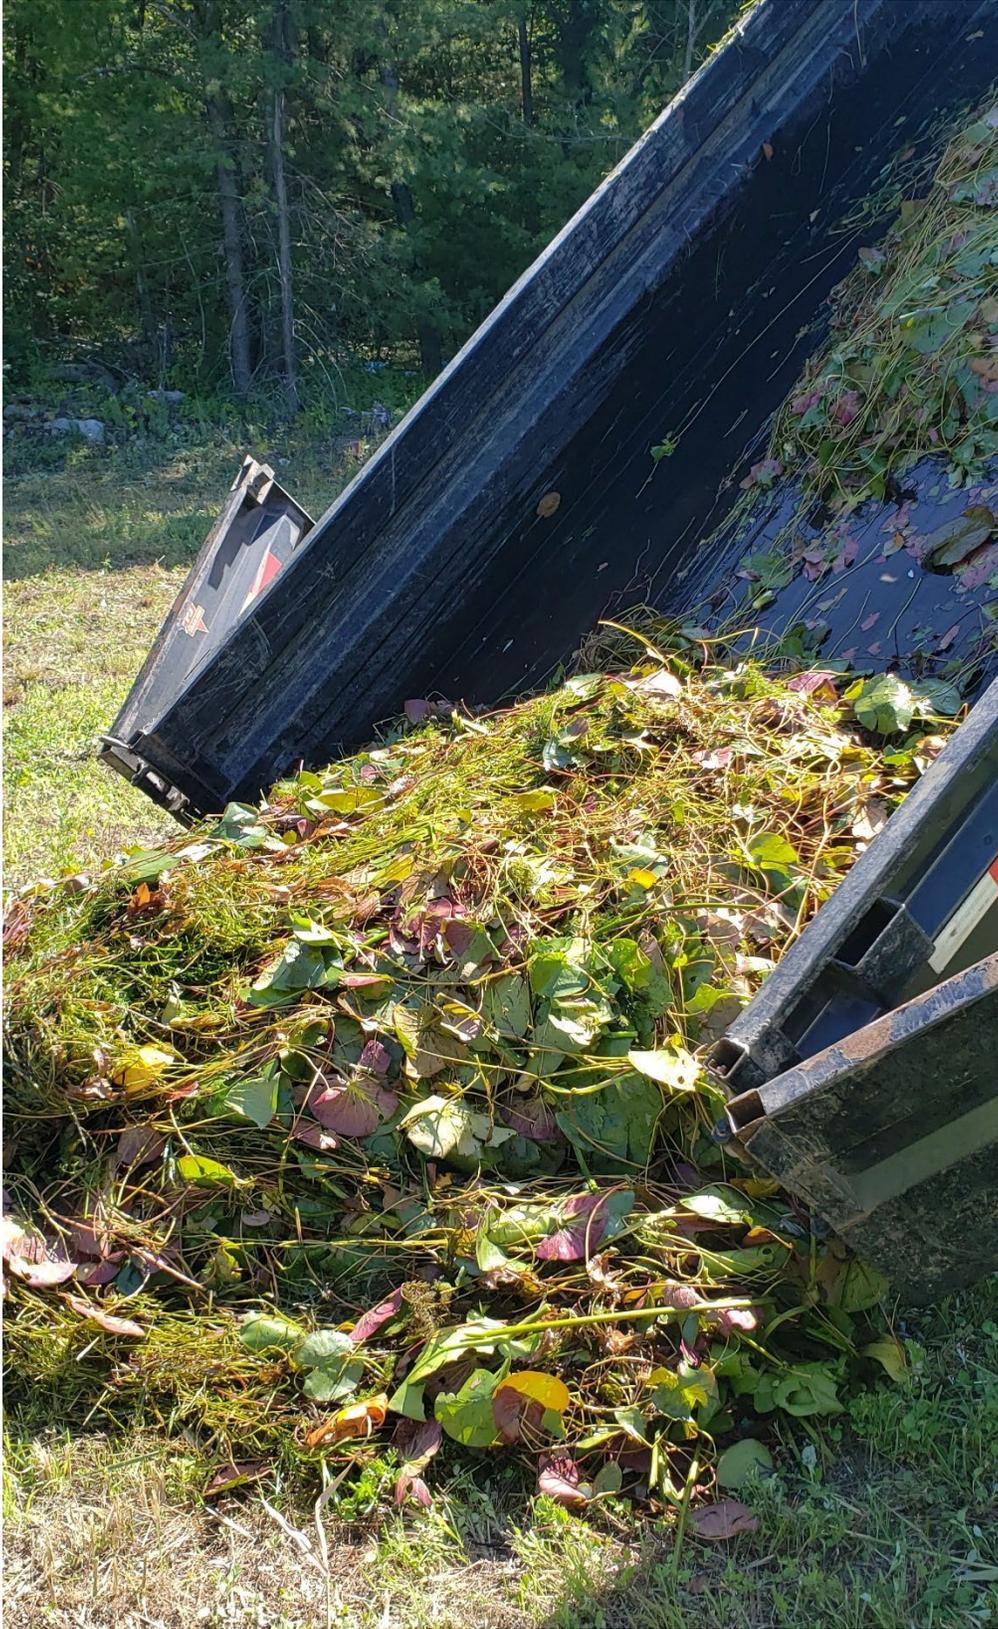
0945 – Eco Harvester empties 1st load of harvested vegetation into dump trailer; ~3 cu yds. The harvested material appears to be predominantly water lily (native) plants; sparse fragments of Eurasian milfoil (invasive) observed.

Figure 1. First load from Eco Harvester being stockpiled at 40 Swain Road.

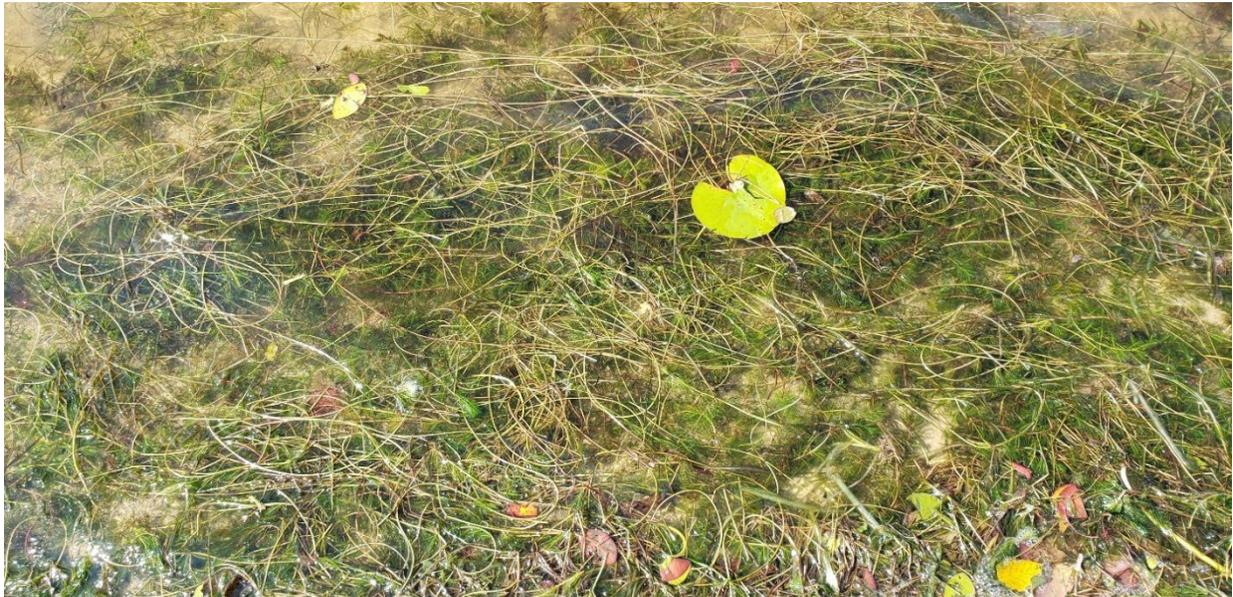
0800 – DPW onsite at Varney Beach. C&D onsite. The Eco Harvester already operating in the central/Southern portion of lake. Upon arriving onsite, DPW observed significant fragmented plant material (mainly Eurasian milfoil (invasive), but some water lily (native) fragments also observed) along shoreline, as well as yellowish foam along shoreline that was not present yesterday.

Figure 2. Fragmented plant material along shoreline

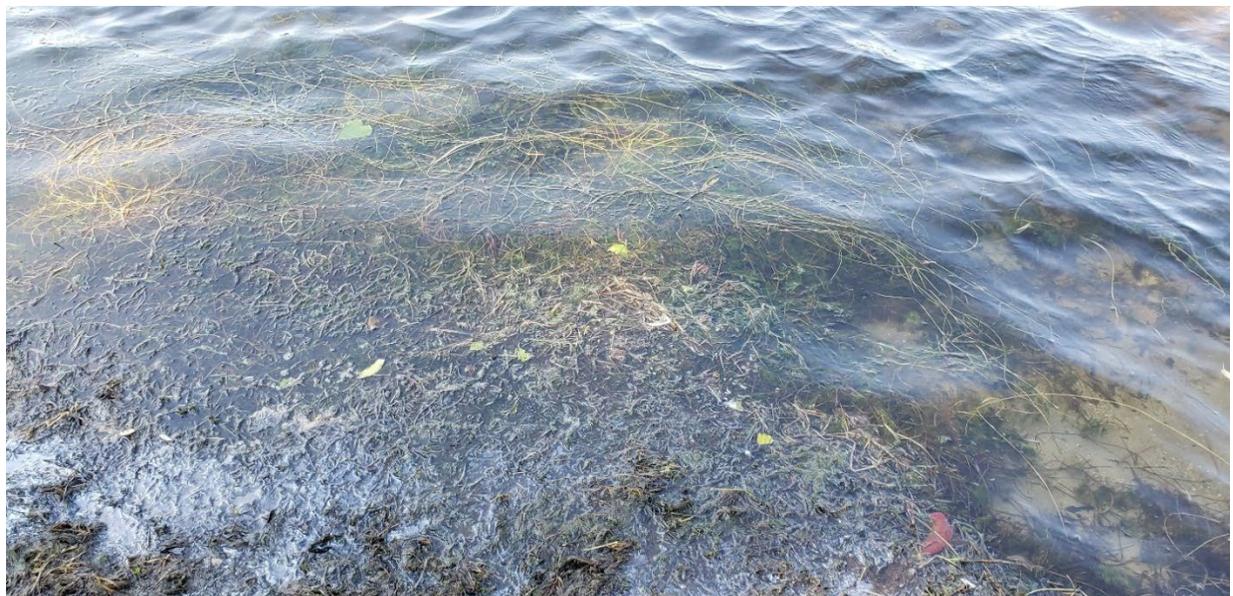
Figure 3. Milfoil fragments along shoreline

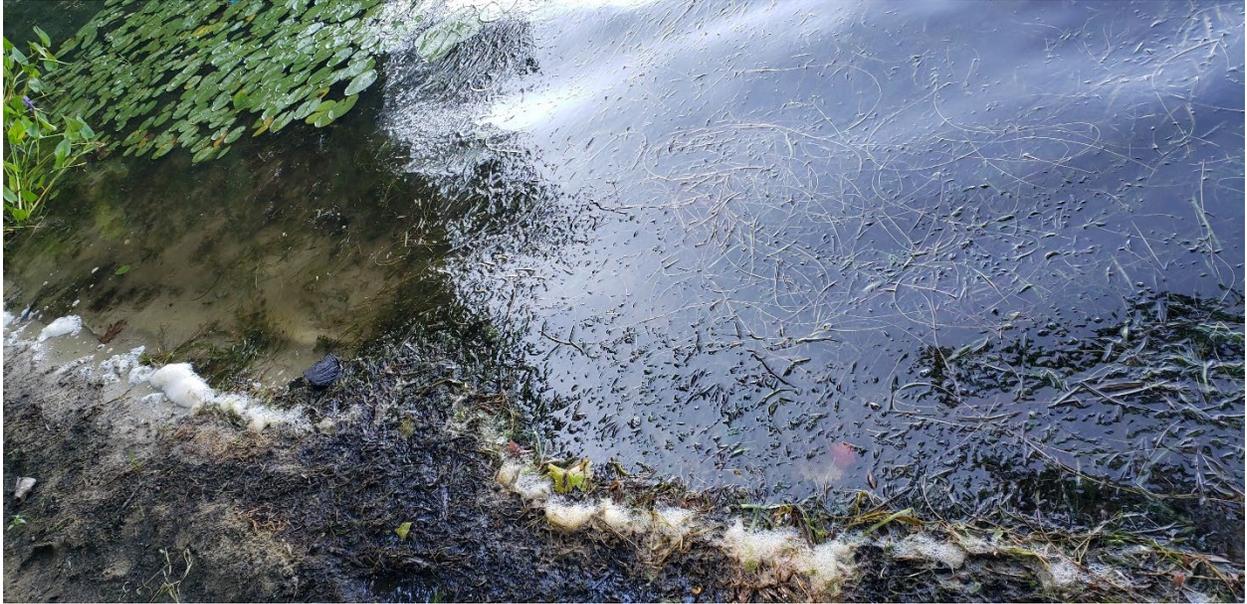
Figure 4. Foam and fragmented plant material along shoreline

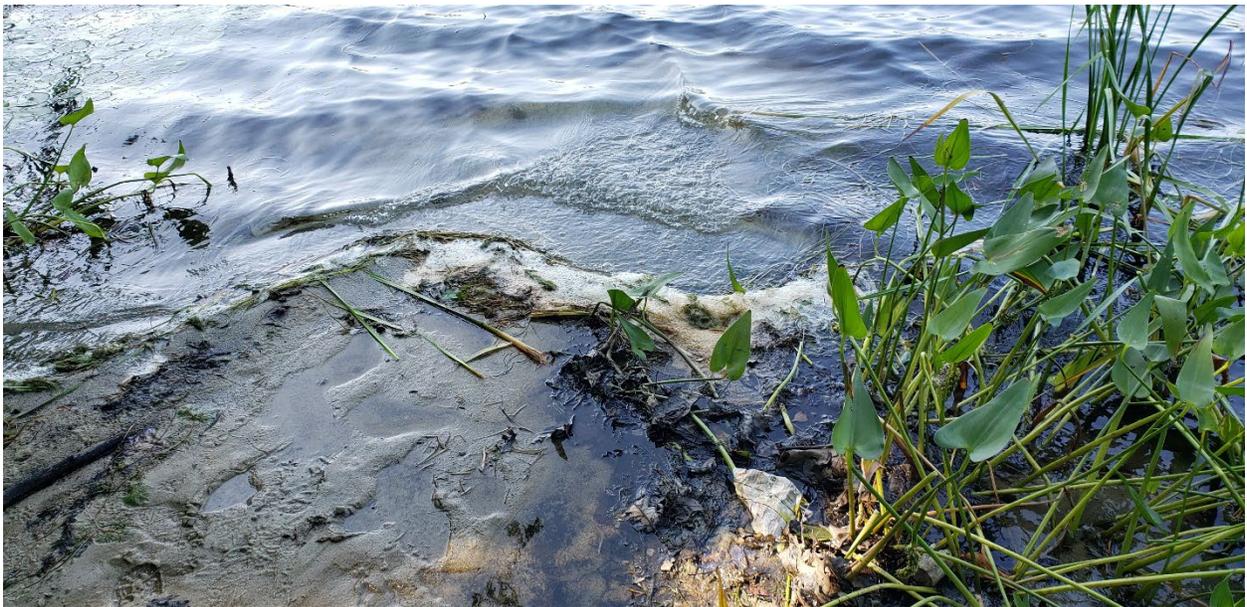
Figure 5. Foam along shoreline

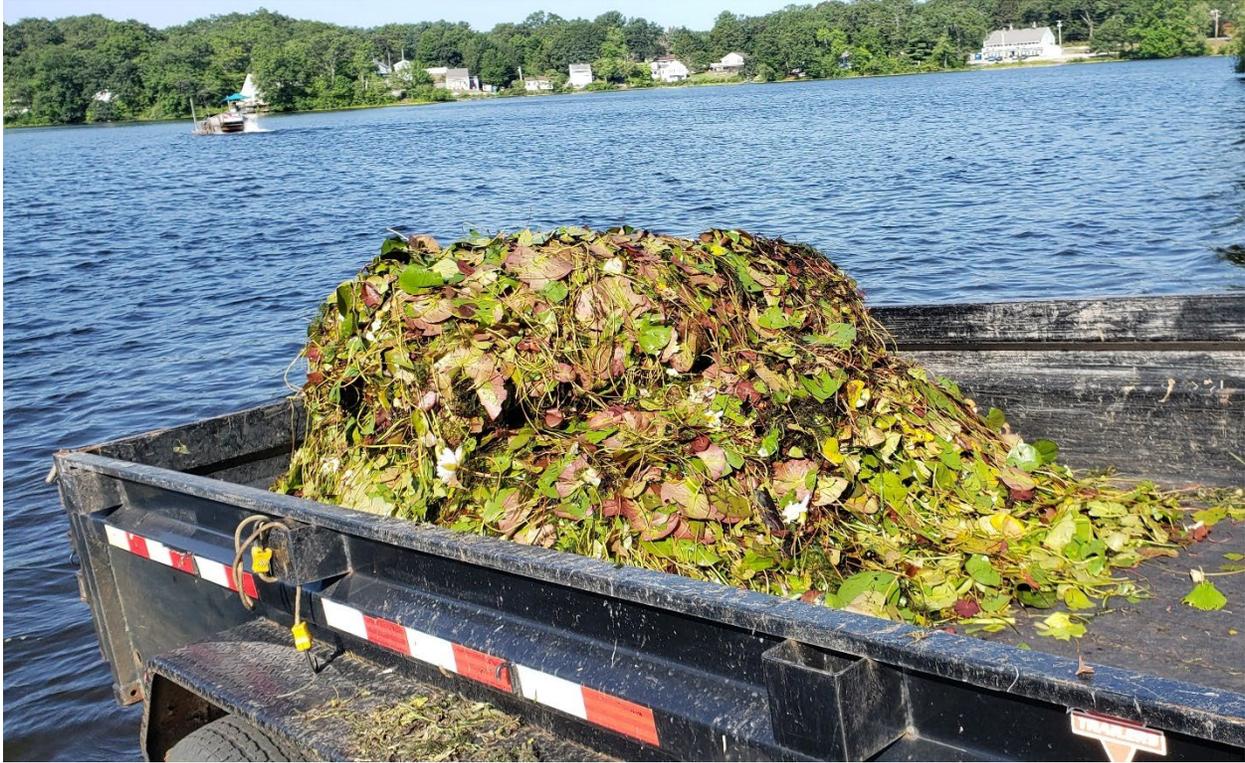
0844 - Eco Harvester empties 1st load of harvested vegetation into dump trailer. The harvested material appears to be predominantly water lily (native) plants; sparse fragments of Eurasian milfoil (invasive) observed.

Figure 6. First load of vegetation harvested on 7/24/25

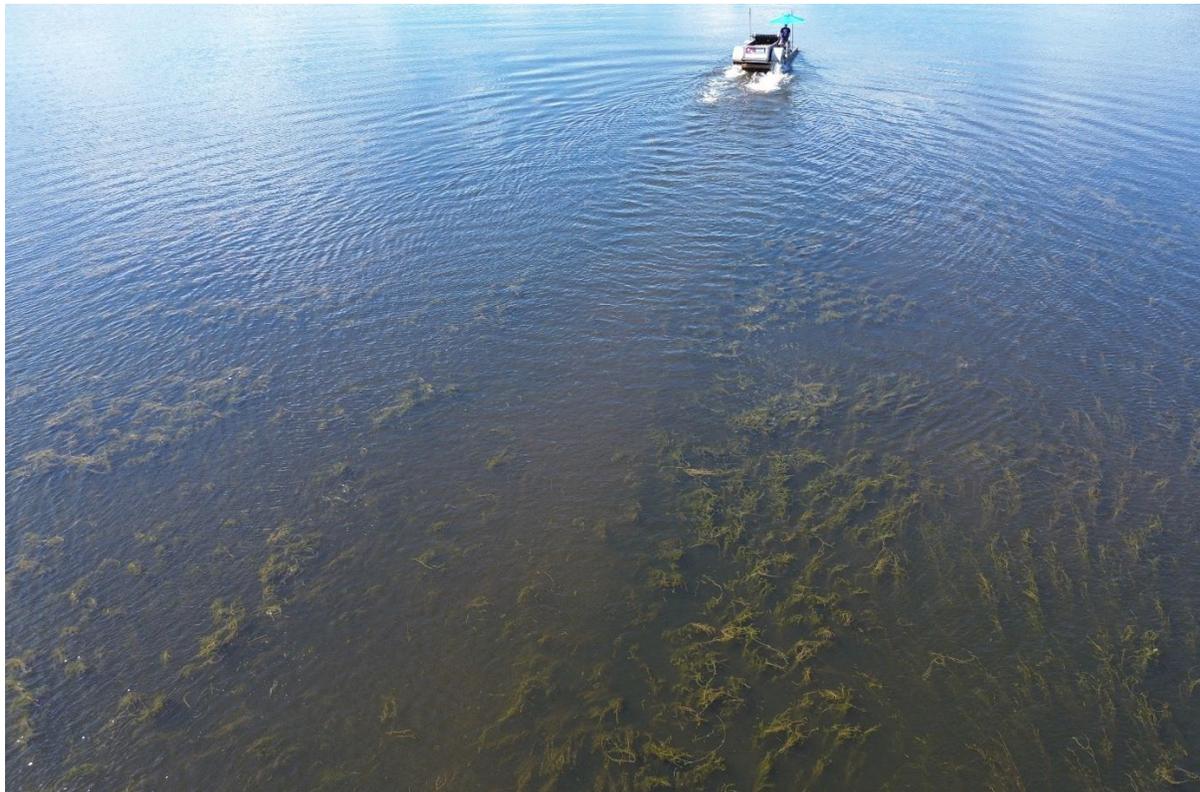
15:00 – Aerial imagery showing the persistence of submerged milfoil plants following mechanical treatment using Eco Harvester.

Figure 7. Submerged milfoil plants observed post-Eco Harvester treatment

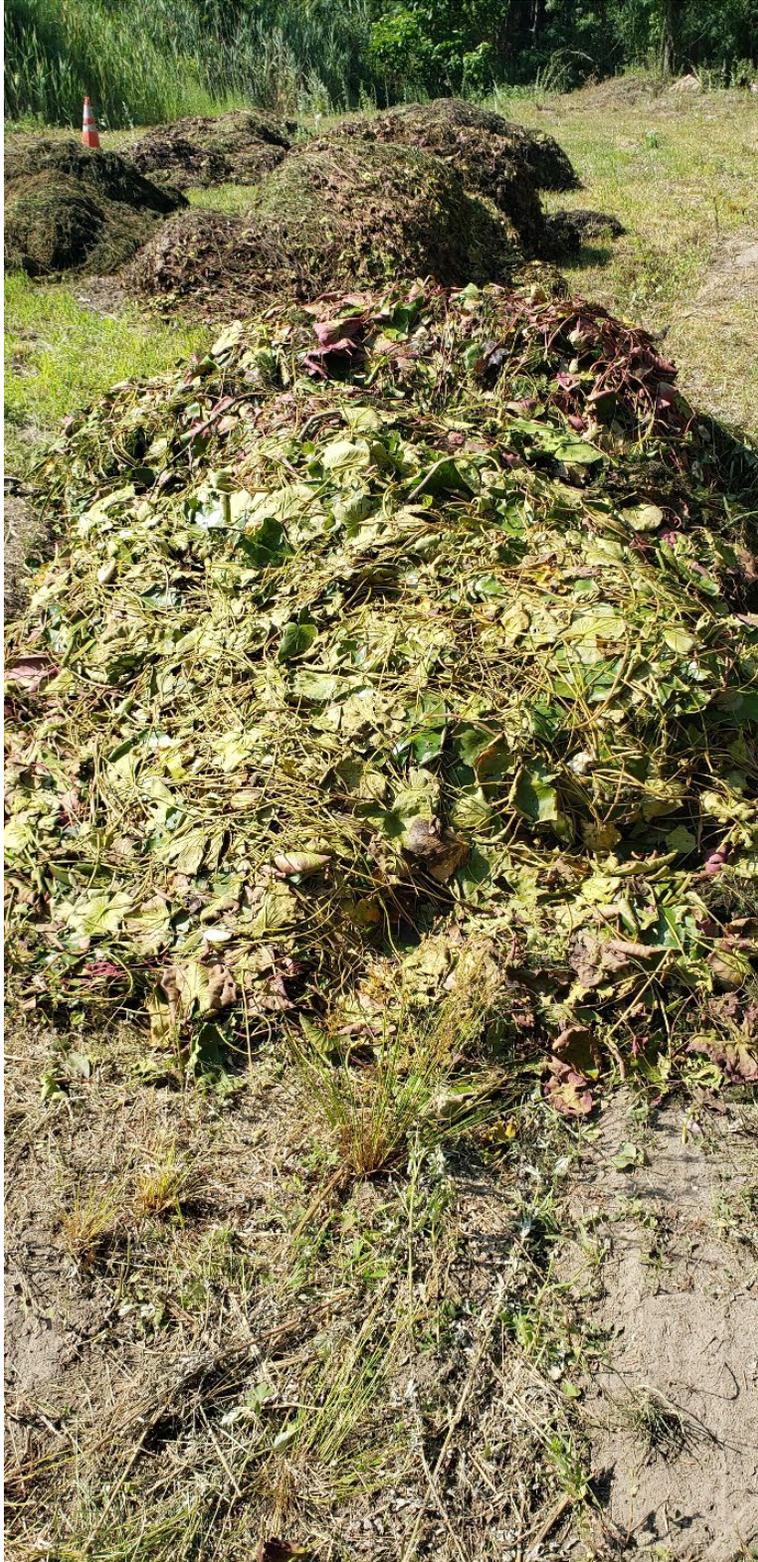
1635 – C&D offsite. CT to 40 Swain Road to evaluate harvested vegetation piles. Harvested vegetation predominantly composed of water lily (native) plants. The only stockpile that consisted primarily of milfoil plants was the material raked from the shoreline by Facilities. CT sifts through piles; no milfoil roots observed; unable to find milfoil fragment longer than ~2 ft.

Figure 8. Stockpiles at 40 Swain Road

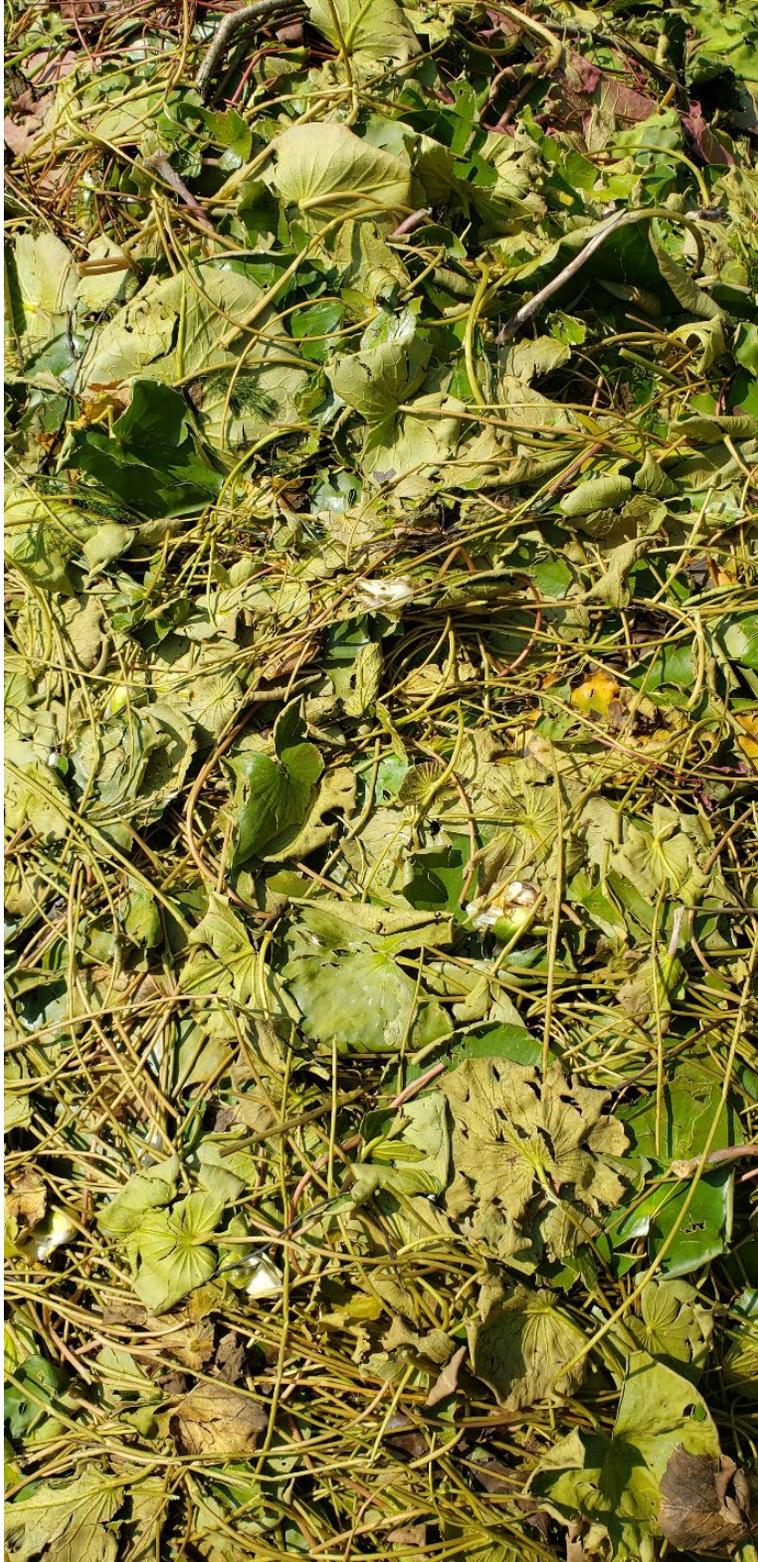
Figure 9. Stockpiled material at 40 Swain Road

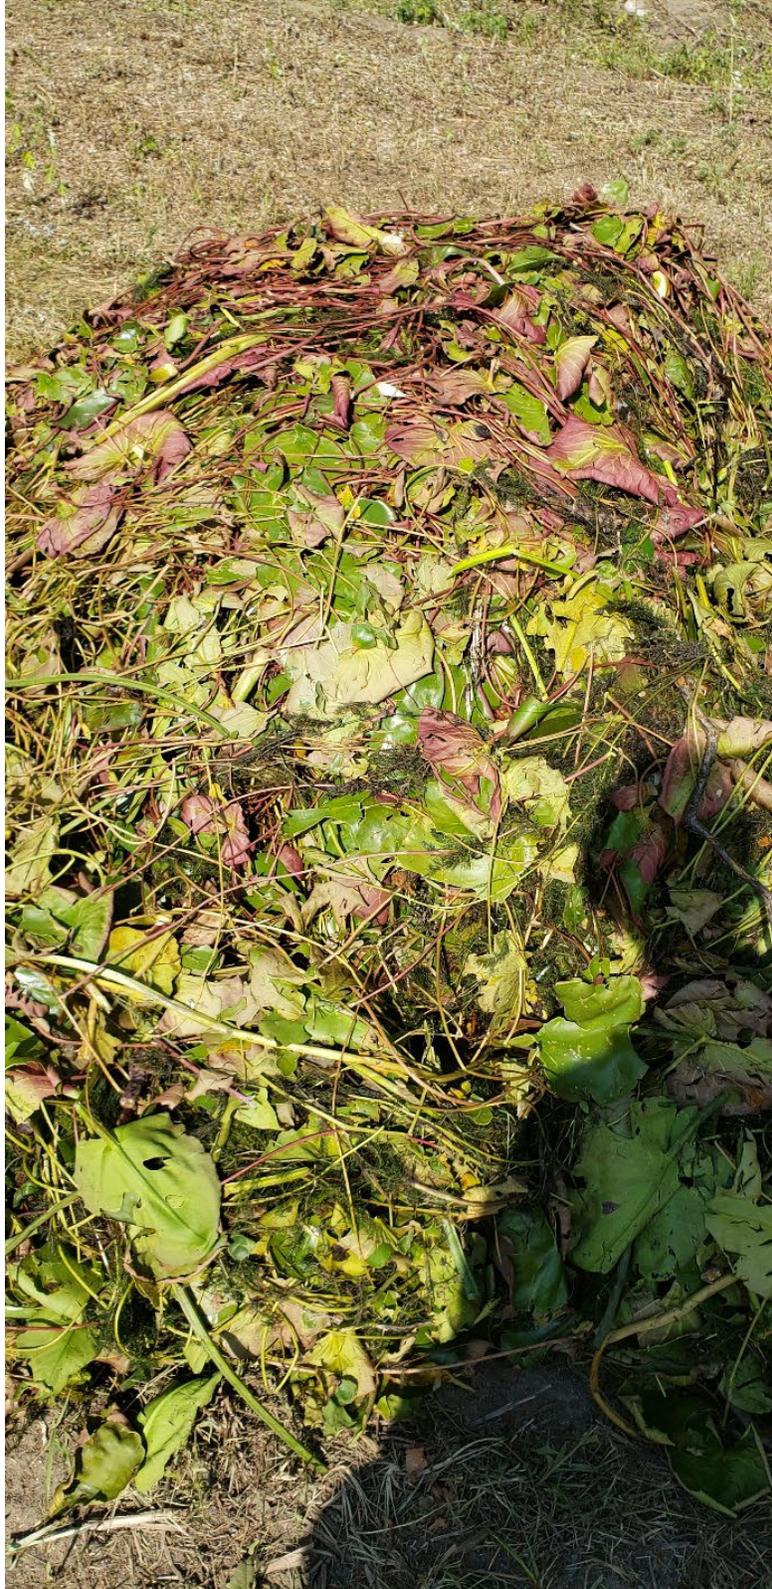
Figure 10. Stockpiled material at 40 Swain Road

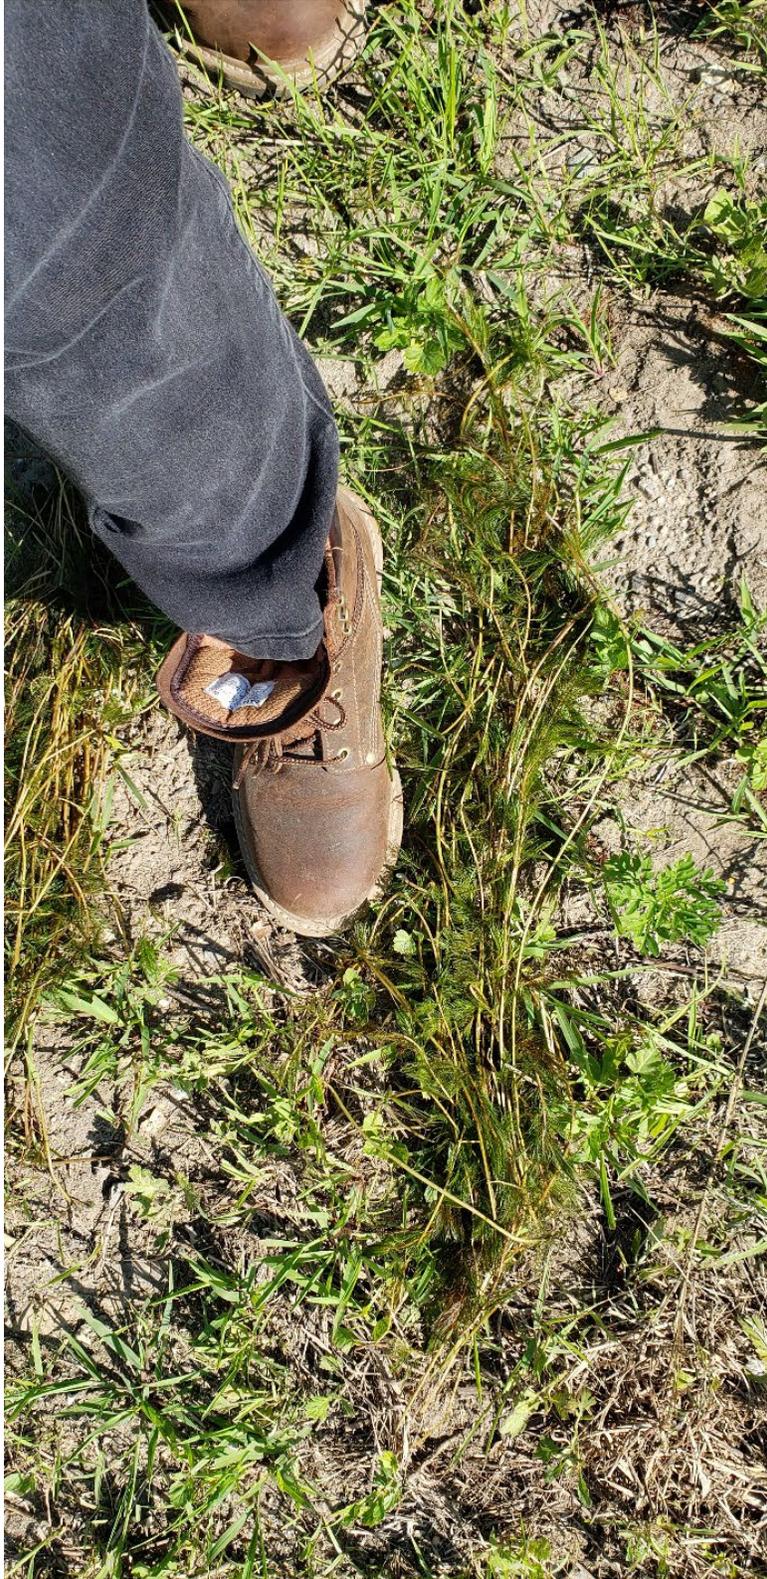
0950 – CT onsite to 40 Swain Road to evaluate biomass that was harvested and stockpiled there yesterday. Piles are predominantly composed of water lilies. Sifted through stockpiles looking for milfoil plants. Removed milfoil plants from piles to look for evidence of roots in harvested material – no milfoil roots were observed. Longest segment of milfoil observed in the piles ~2 ft long, suggesting fragmentation of milfoil plants by the Eco Harvester.

Figure 81. Longest segment of milfoil DPW was able to find in the harvested stockpiles

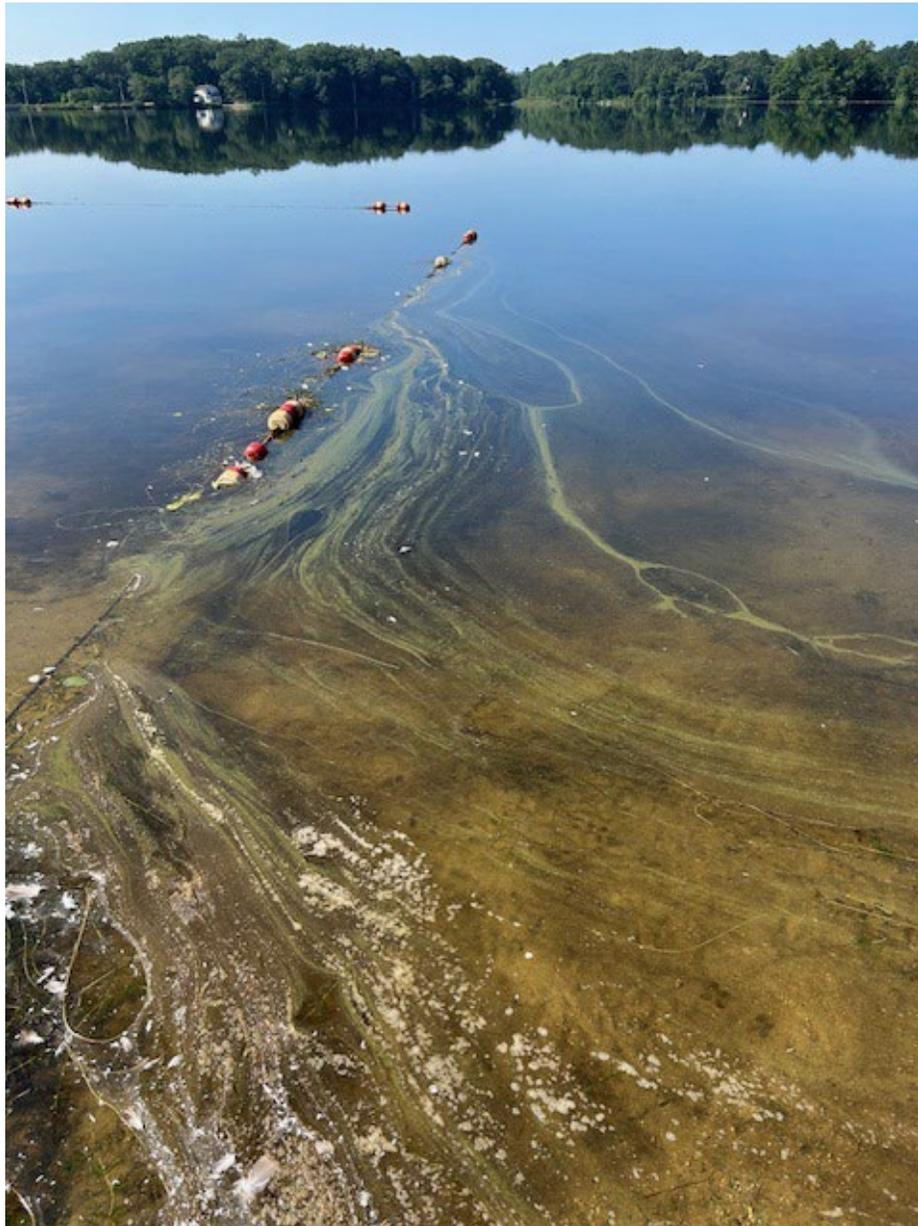
0930 – Chelmsford Board of Health (BOH) Senior Health Inspector, Mark Masiello, visually identifies Cyanobacteria algal bloom at Freeman Lake. Freeman Lake closed to all water activities until further notice.

The occurrence of an algal bloom shortly after the Eco Harvester treatment event is notable. The treatment involved significant agitation and disturbance of the water column, which may have contributed to the bloom. However, a direct link between the two events has not been established and may be coincidental.

Figure 12. Cyanobacteria algal bloom documented by BOH
